The construction of cofferdams Dam No. 26, Alton, Illinois

THE CONSTRUCTION OF COFFERDAMS

DAM NO. 26, ALTON, ILLINOIS

Degree of
CIVIL ENGINEER

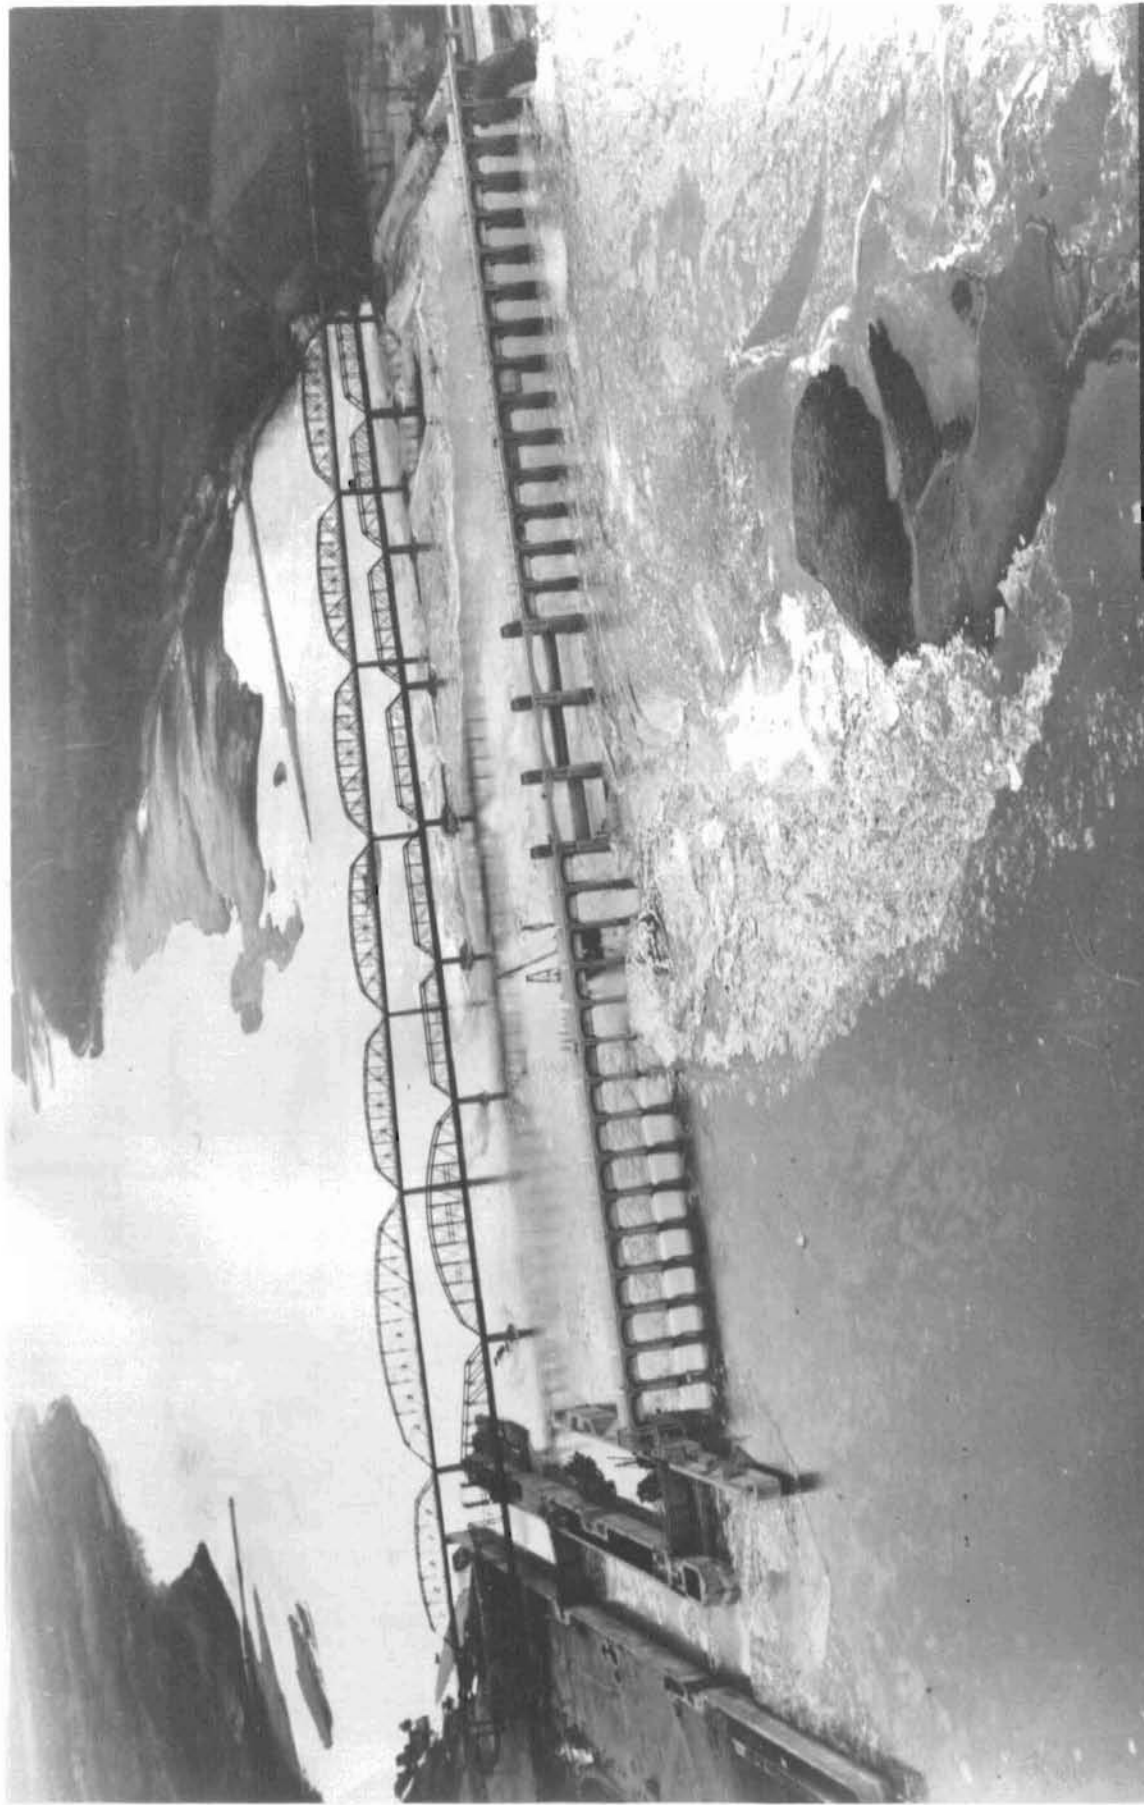
UPPER MISS. RIVER - DAM No. 26
PWA CONTRACT- No.W-1103 ENG.2093
AERIAL VIEW
PHOTO BY AIR CORPS
U.S. ENGINEER OFFICE ST. LOUIS, MO.
DEC.20,1937 No. 3202

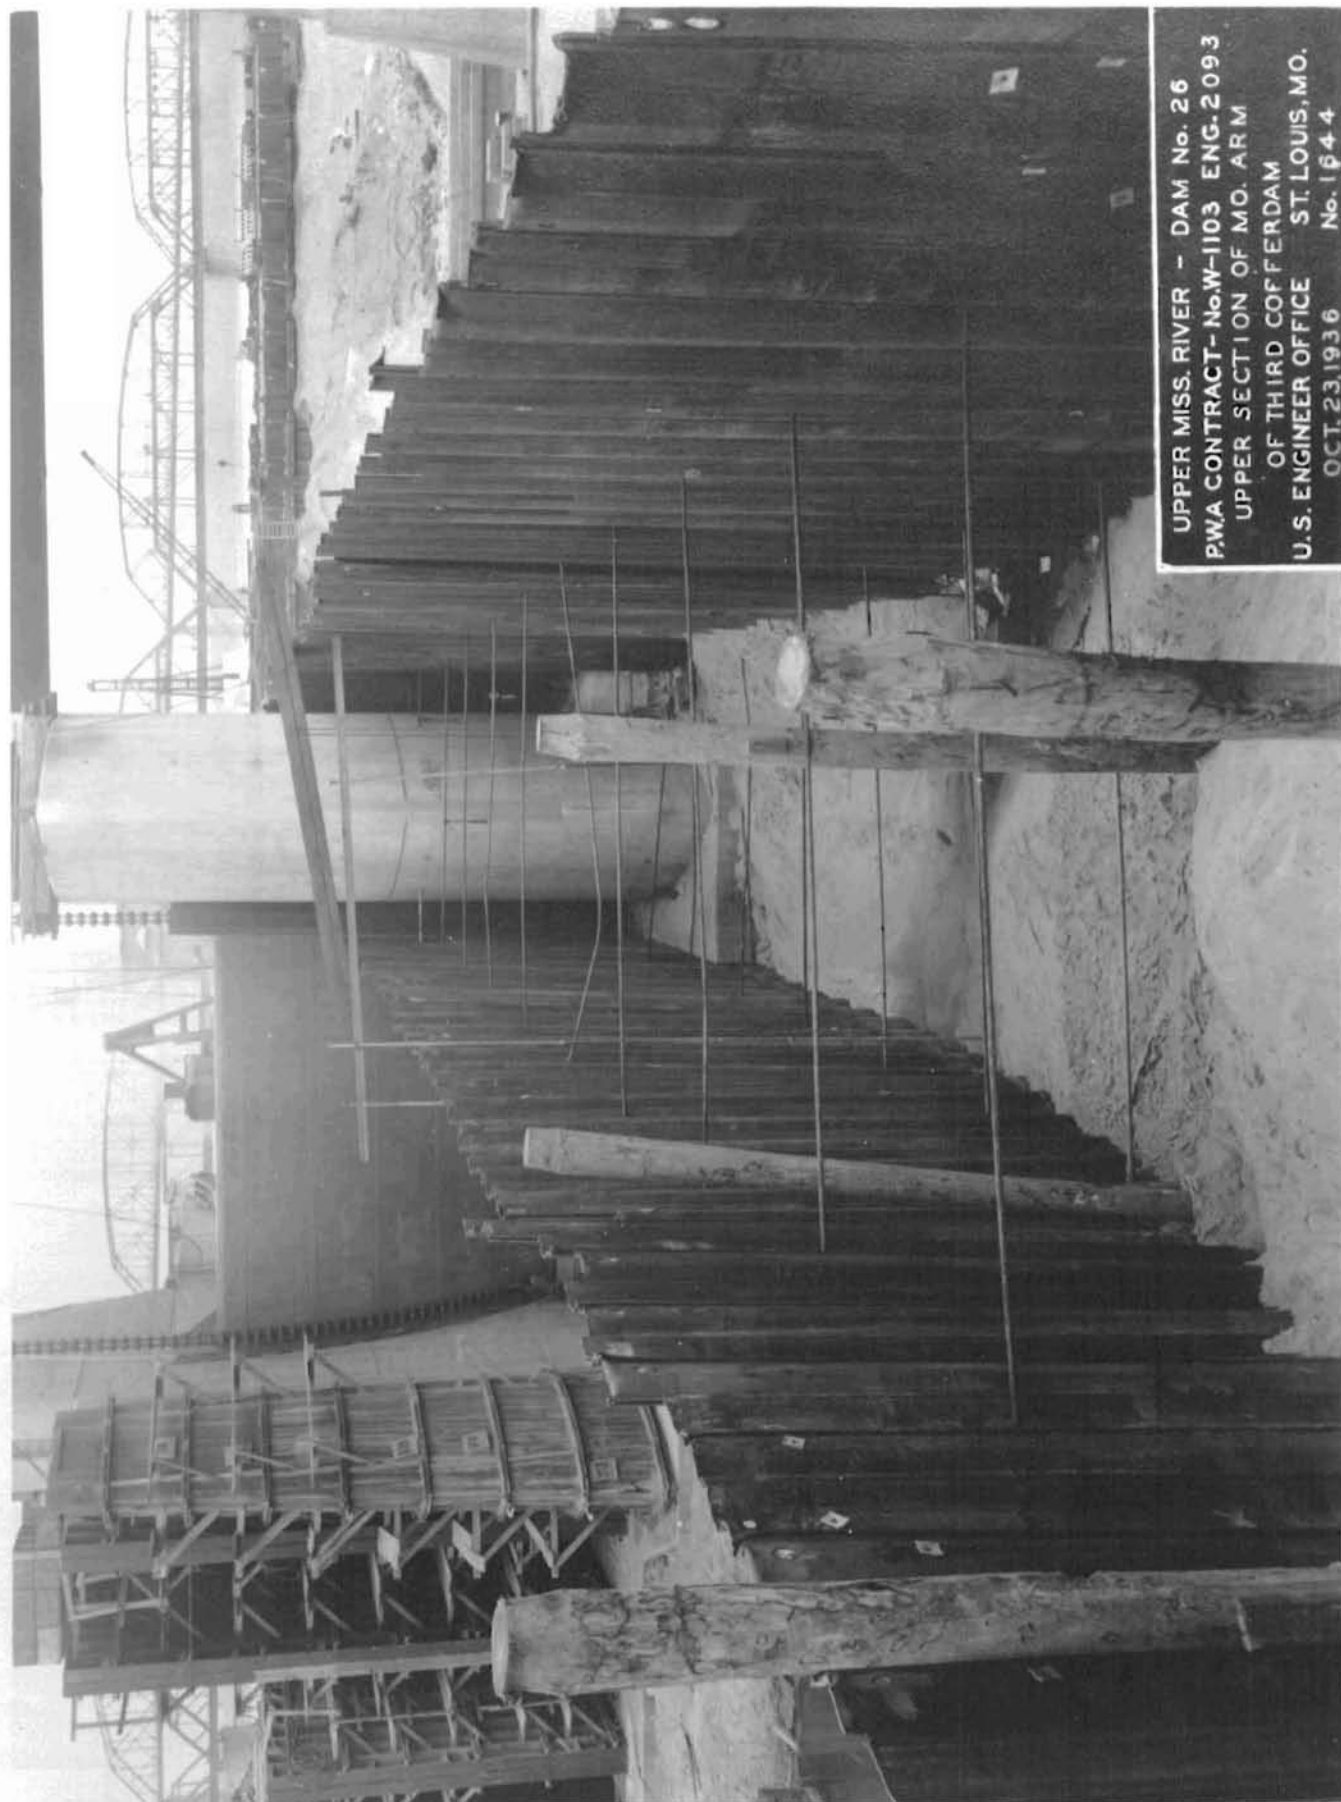
Fig. 7.

UPPER MISS. RIVER - DAM No. 26
PWA CONTRACT - No. W-1103 ENG. 2093
UPPER SECTION OF MO. ARM
OF THIRD COFFERDAM
U.S. ENGINEER OFFICE ST. LOUIS, MO.
OCT. 23, 1936 No. 1644

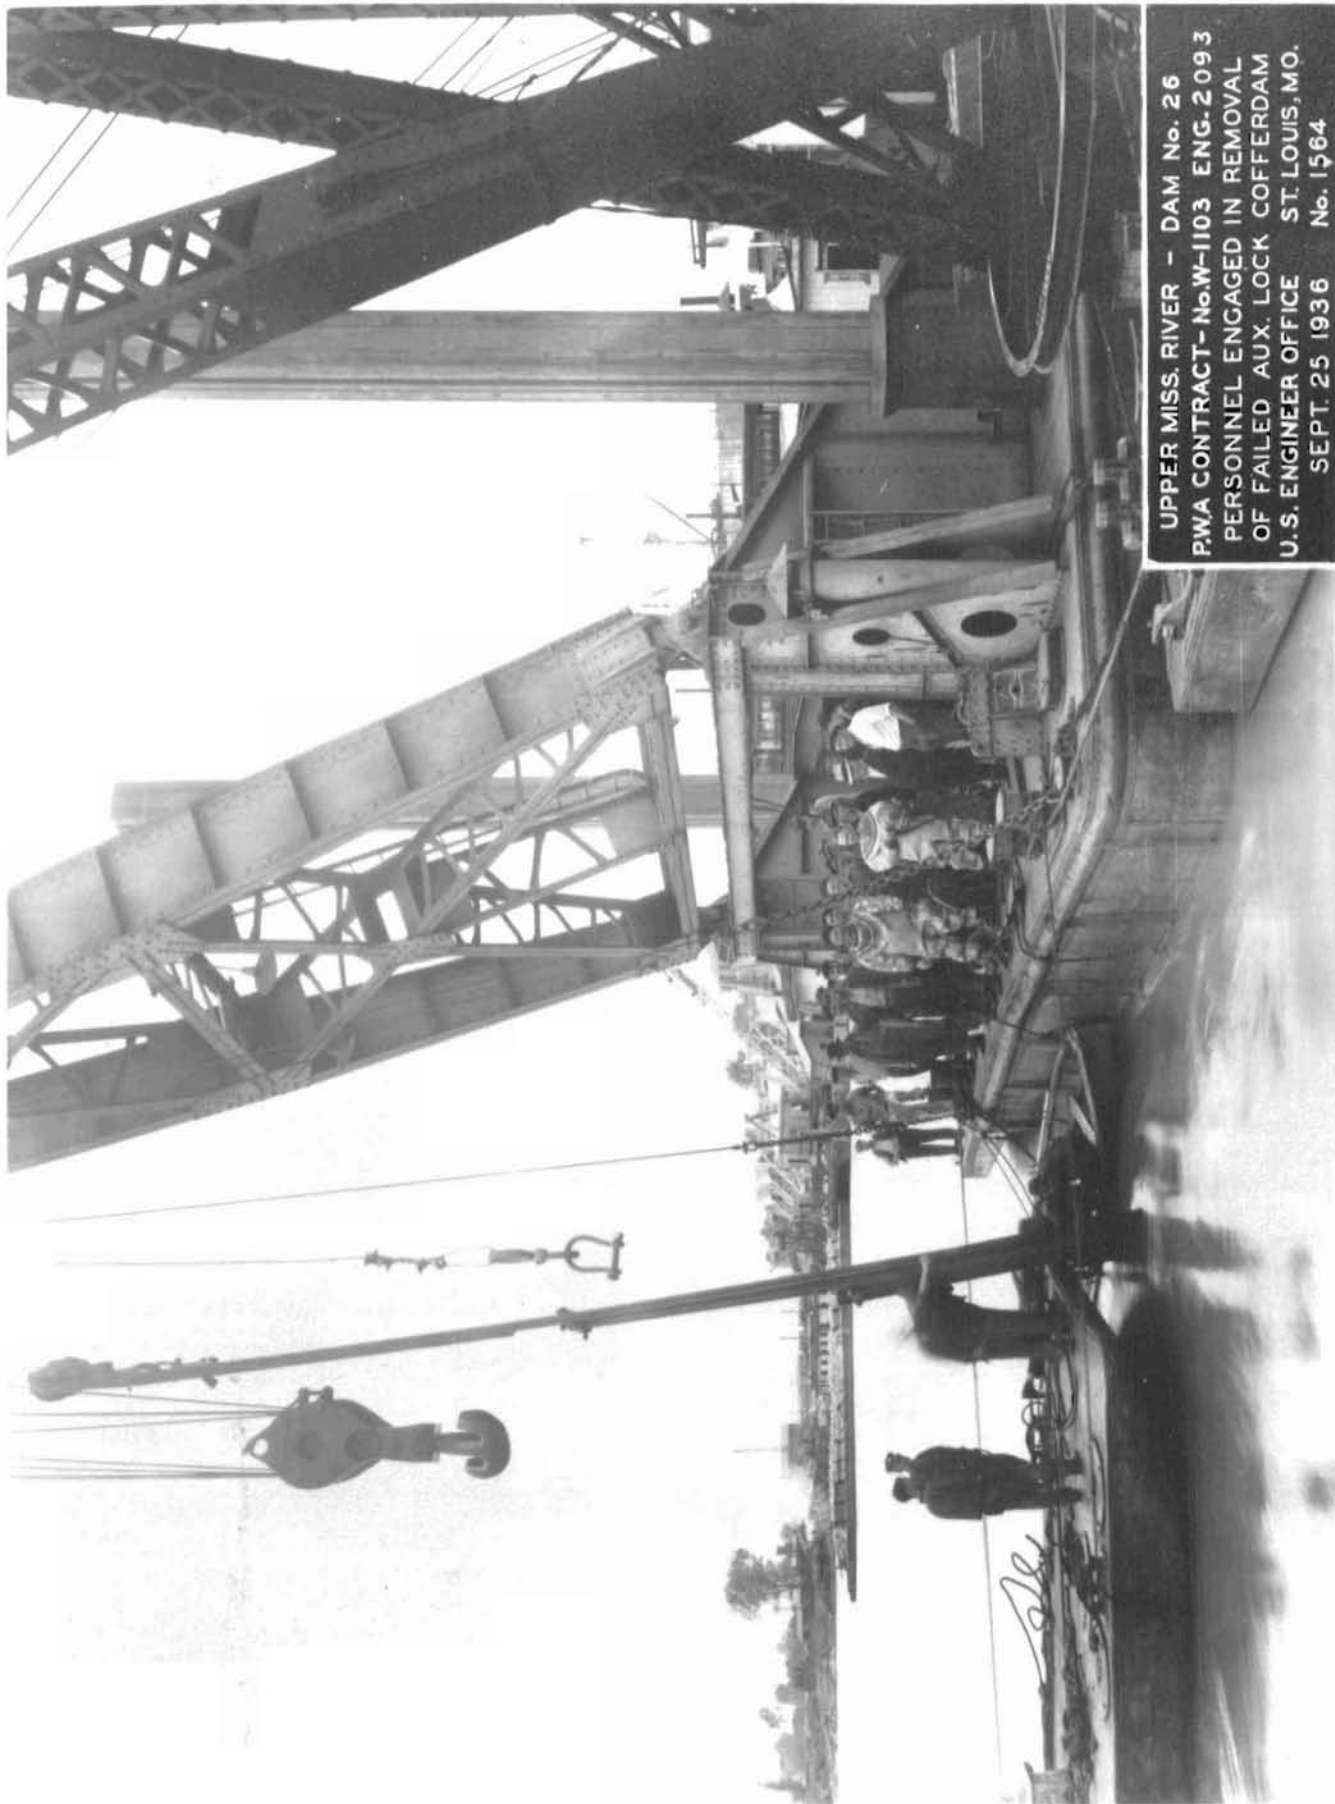
Fig. 10.

UPPER MISS. RIVER - DAM No. 26
PWA CONTRACT- No.W-1103 ENG. 2093
PERSONNEL ENGAGED IN REMOVAL
OF FAILED AUX. LOCK COFFERDAM
U.S. ENGINEER OFFICE ST. LOUIS, MO.
SEPT. 25 1936 No. 1564

A large derrick boat, a smaller derrick boat and a pile driver belonging to the U. S. Engineer Dept. were then employed to remove this wreckage. Two divers were let down to the bottom and they burned holes in the steel sheets. A clasp was bolted thru these holes and the sheets were hauled up in sections vary-

ing in size from a part of a sheet to sections of several sheets threaded together. (See Fig. 10).

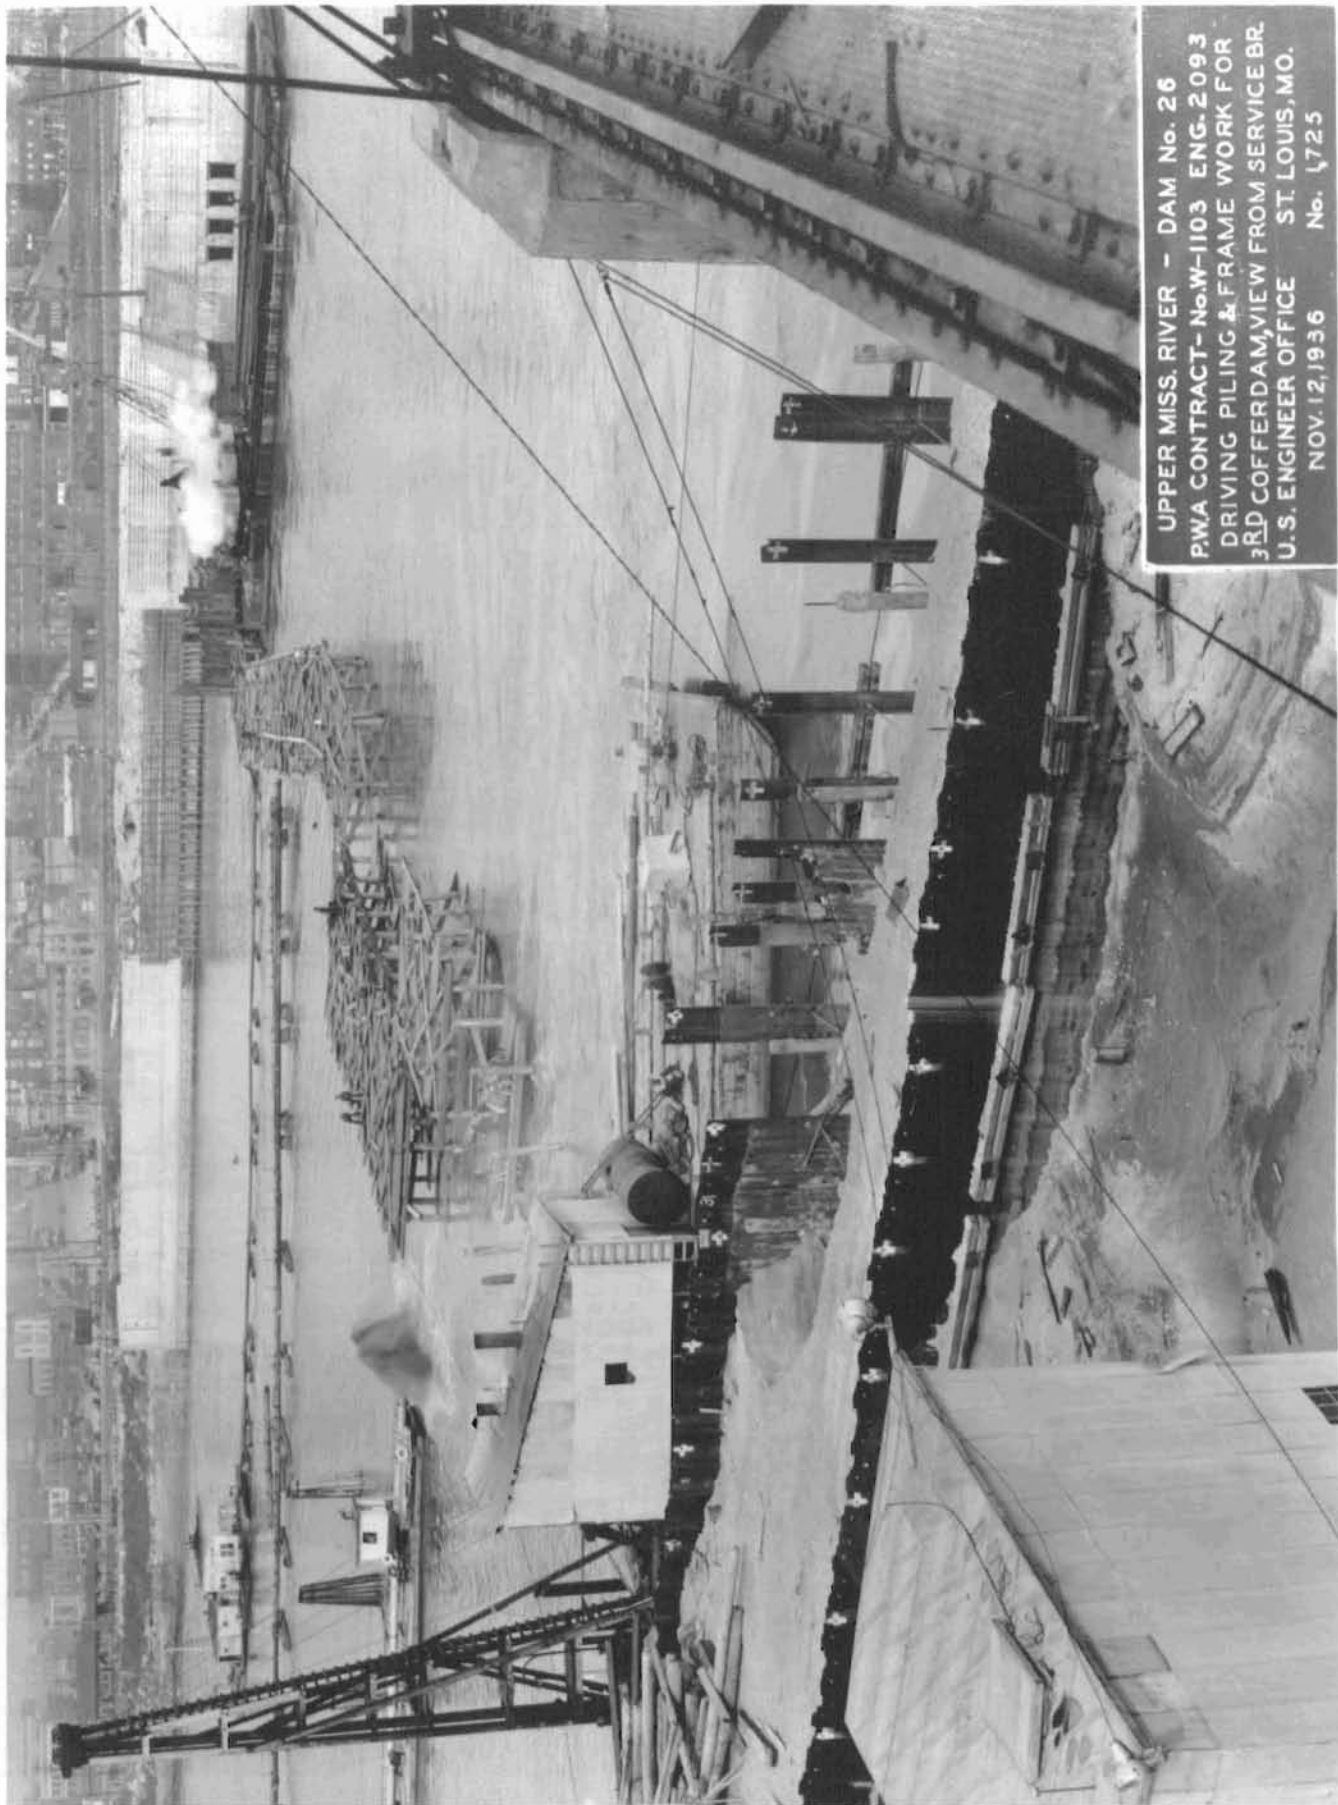
Fig. 11.

UPPER MISS. RIVER - DAM No. 26
 PWA CONTRACT- No.W-1103 ENG.2093
 DRIVING PILING & FRAME WORK FOR
 3RD COFFERDAM, VIEW FROM SERVICE BR.
 U. S. ENGINEER OFFICE ST. LOUIS, MO.
 NOV. 12, 1936 No. 1725

The closure was made in similar manner as the closure of the upper arm of the second section, using the trestle for guide and support. (See Fig. 11).

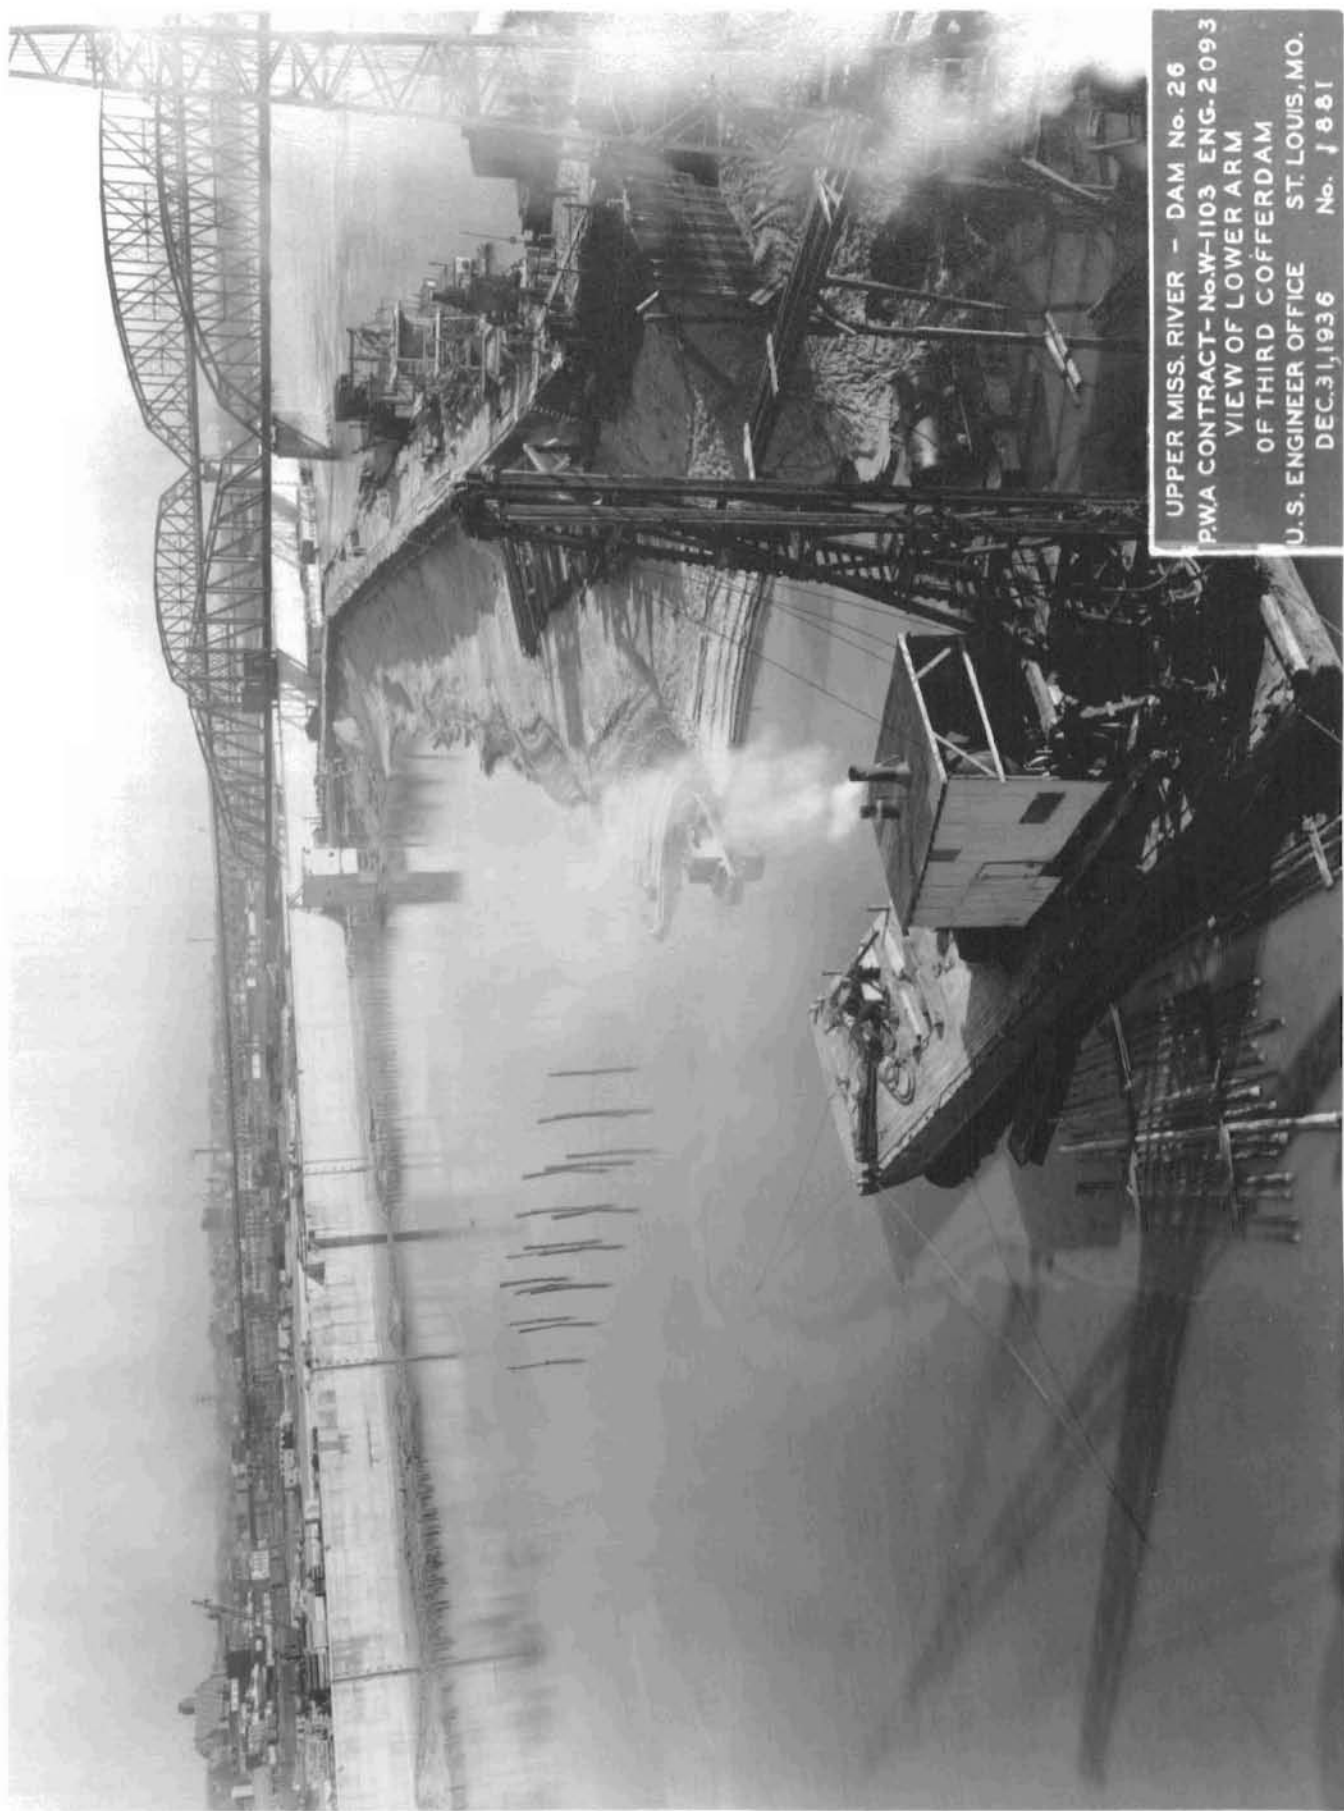
Fig. 12.

UPPER MISS. RIVER - DAM No. 26
P.W.A CONTRACT-NO.W-1103 ENG. 2093
VIEW OF LOWER ARM
OF THIRD COFFERDAM
U.S. ENGINEER OFFICE ST. LOUIS, MO.
DEC. 31, 1936 No. J 881

The lower arm was started Nov. 21, 1936 with the driving of the timber pile for falsework, followed with the sheet piling. The lower arm angled down stream from the lower Illinois end of the second cofferdam to the intermediate lock wall. (See Fig. 12) The lock wall acted as the arm on the Illinois side.

After the pumps were set up and the cofferdam completed, dewatering of the cofferdam was started. This was not just a case of pumping the water out of the inclosure as quickly as possible. As the water level was lowered a strict vigilance was maintained on the berms. If the berms showed signs of weakness, the pumps were stopped intermittently to maintain a certain level or even stopped altogether to allow a maintenance crew to strengthen the berm. This was done either by clamping sand and placing it on the berm or by men placing two inch stone along the toe of the slope, causing a terrace effect. This process of dewatering was used in each of the three cofferdams, lowering the water until the level required to maintain a dry bottom for foundation work. The water might have been pumped out in one-third the time required but at a sacrifice of the supporting berm. (Fig. 12 shows the effect of placing stone along toe of berm.)

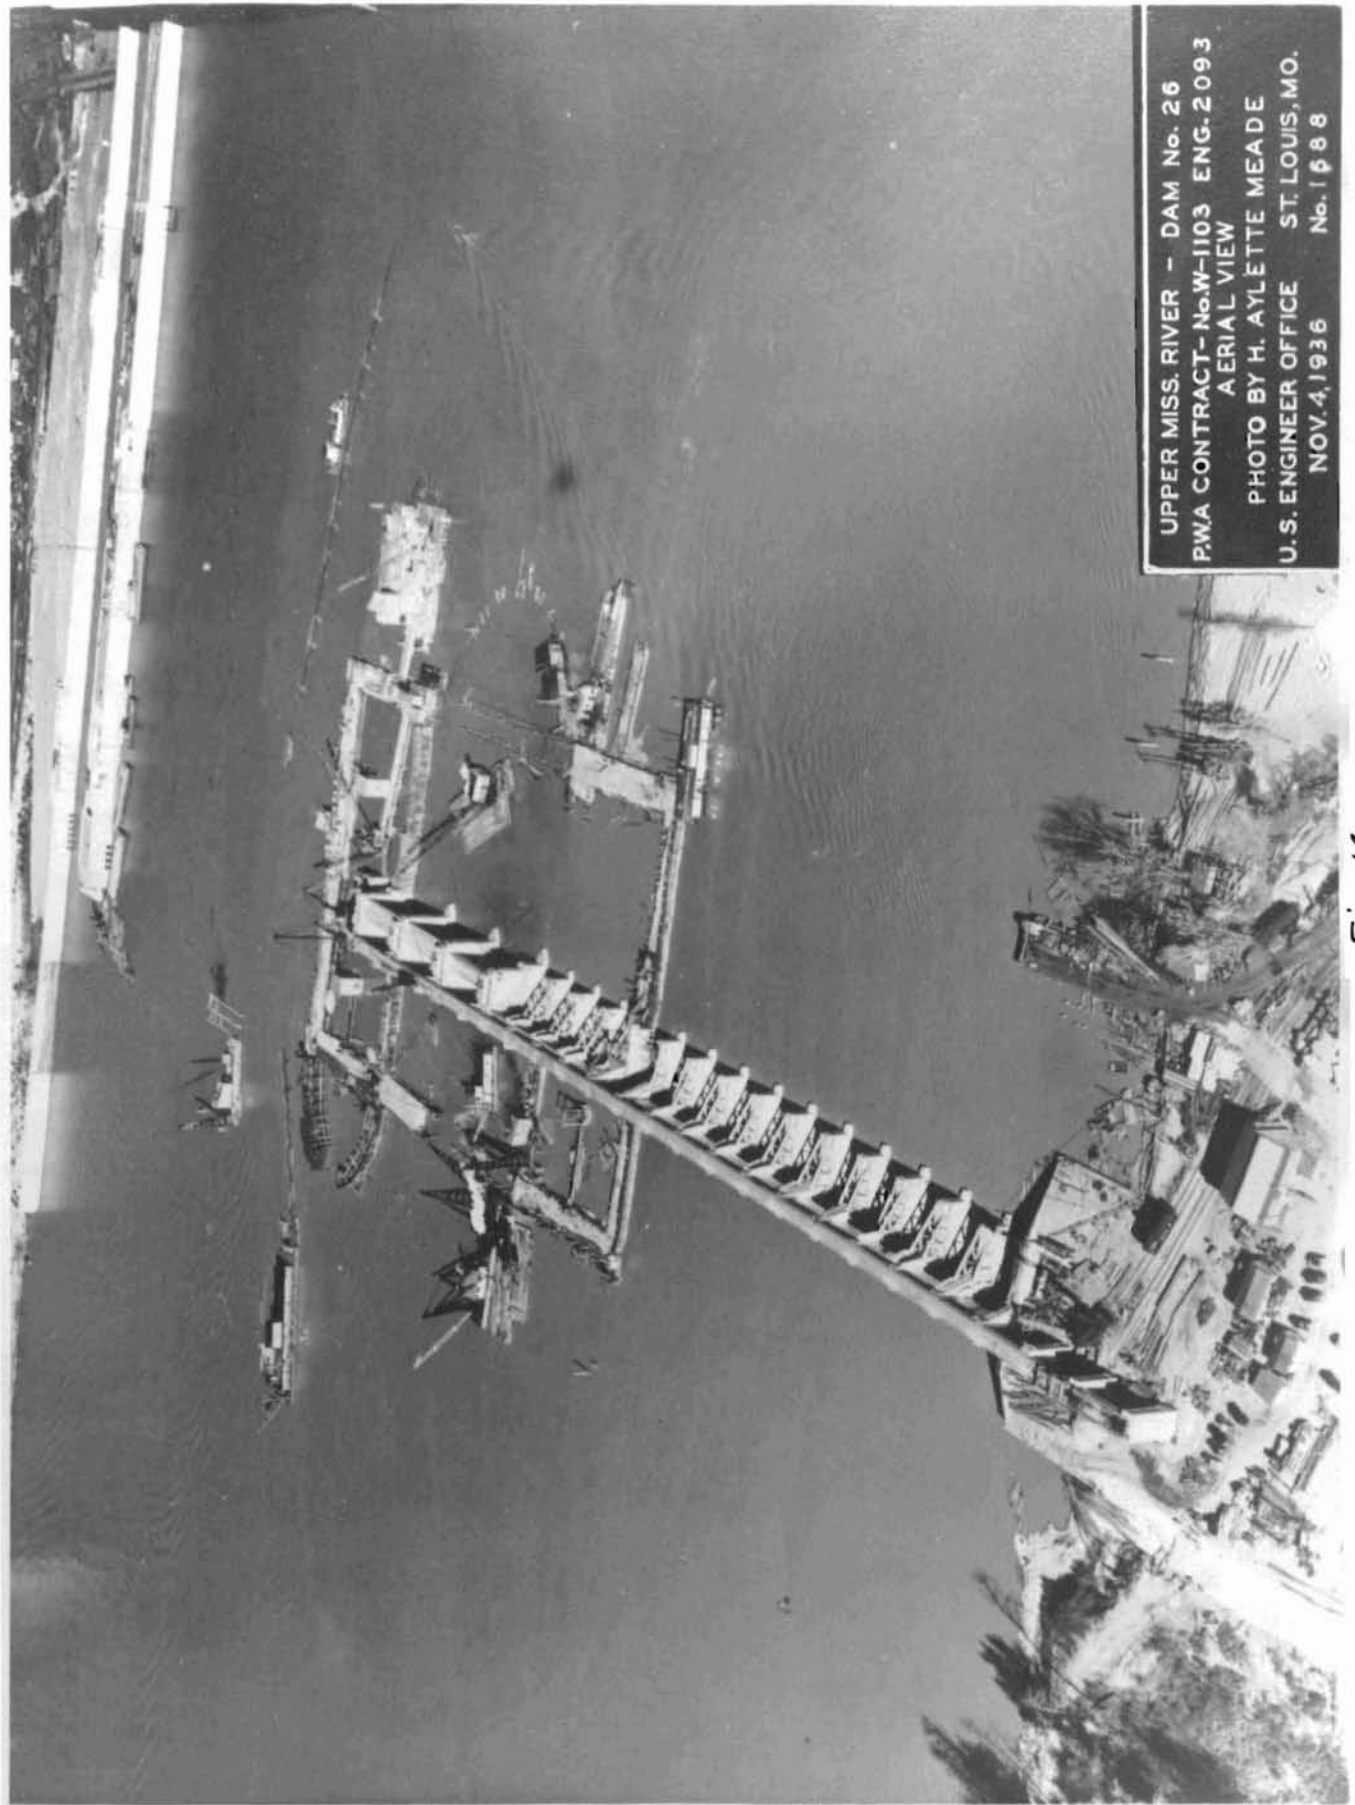
UPPER MISS. RIVER - DAM No. 26
P.W.A CONTRACT-No.W-1103 ENG-2093
AERIAL VIEW
PHOTO BY H. AYLETTE MEADE
U.S. ENGINEER OFFICE ST. LOUIS, MO.
NOV. 4, 1936 No. 1688

The second cofferdam inclosure was flooded on October 23, 1936 and extraction of the sheeting in the upper arm was started October 26, 1936. The same procedure was used as on the first cofferdam with the exception that removal of the downstream arm was made at the same time as the upstream arm. (See Fig. 14 aerial photograph showing partial removal of second cofferdam.) The dredge removed the berms of these walls, placing the fill in the Missouri arm of the third cofferdam. Removal of the Missouri arm of the second cofferdam was started Nov. 2, 1936 and removal of the Illinois arm was started Nov. 9, 1936. The fairly low stage of the river made possible the removal of all the arms of the second cofferdam at the same time. This was not feasible in the first. However, the upper arm of the third cofferdam was under construction when the Illinois arm of the second
